## Spanish Key Condominium

Perdido Key, Florida

## Reserve Study

2018

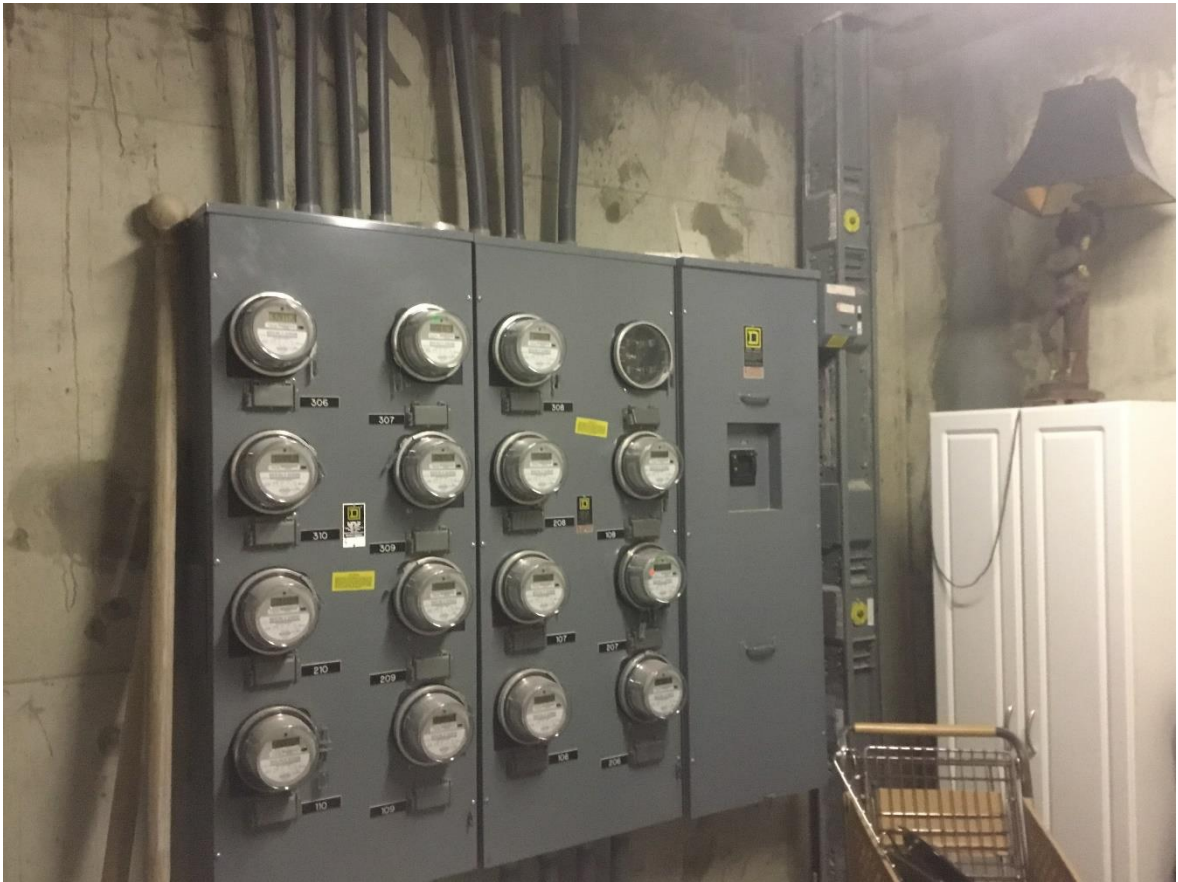
**EXHIBIT NUMBER: 1.19**

This picture depicts a portion of the building electrical system.

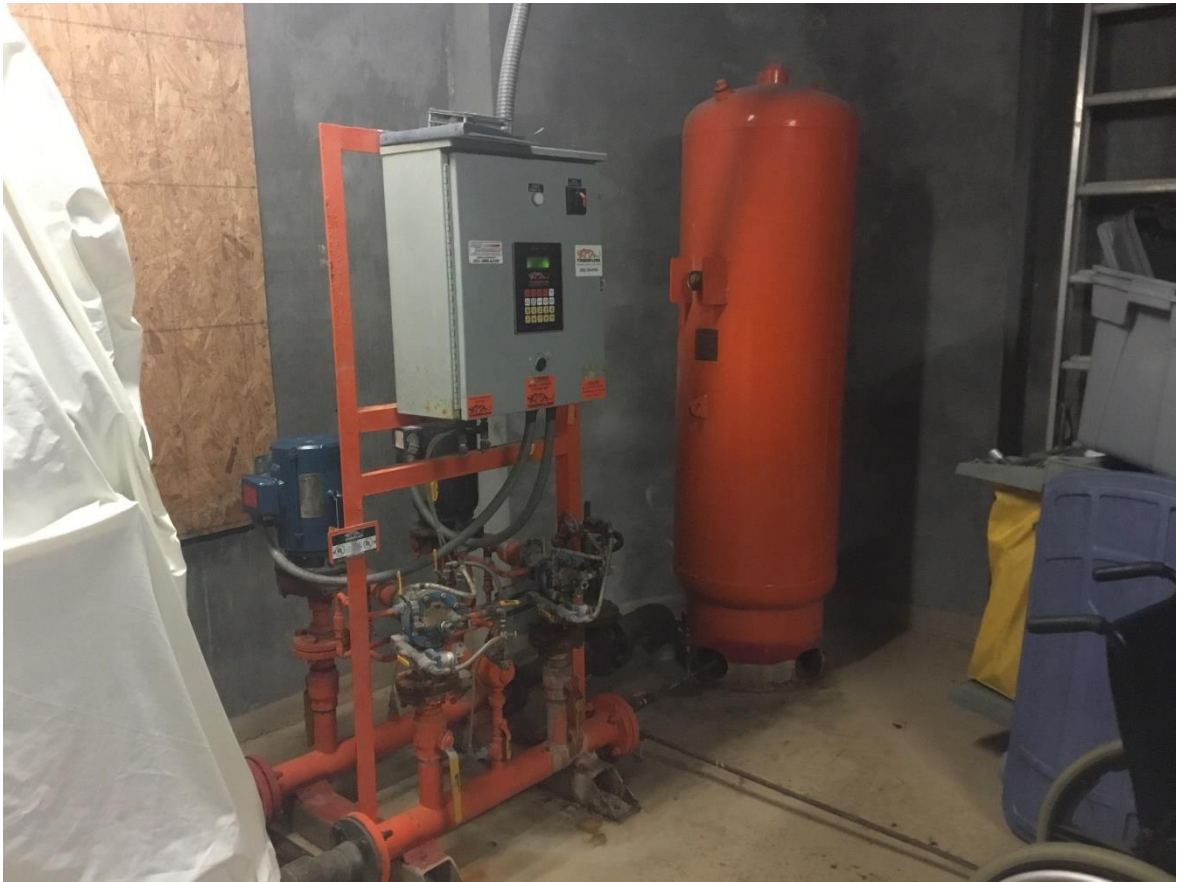
**EXHIBIT NUMBER: 1.21**

This picture depicts a portion of the potable water distribution system booster pumps and controls. The booster pumps and controls were observed to be in “fair” condition.

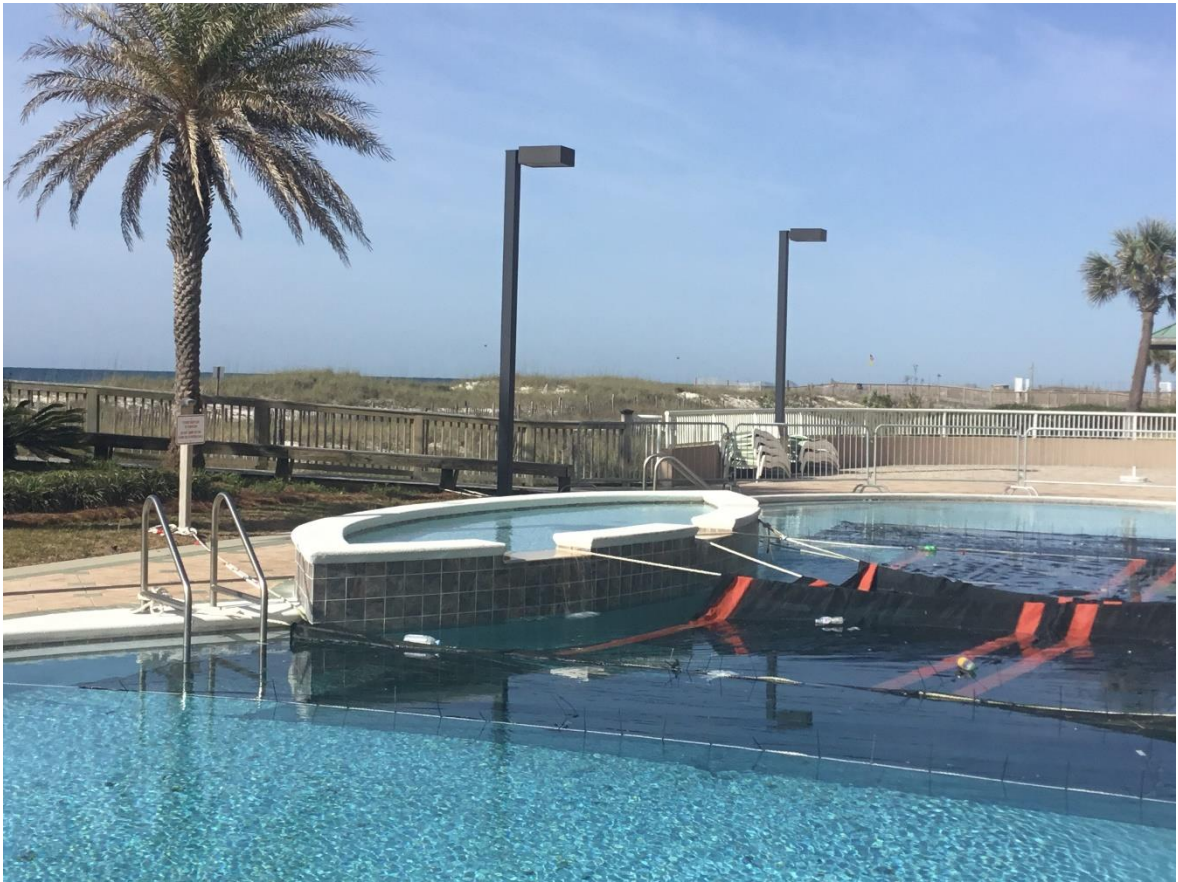
**EXHIBIT NUMBER: 1.24**

This picture depicts a portion of the outdoor pool and associated pool deck. The outdoor pool was observed to be in “good” condition. The tarp in the pool is temporary as a portion of the rear elevation is currently being renovated.

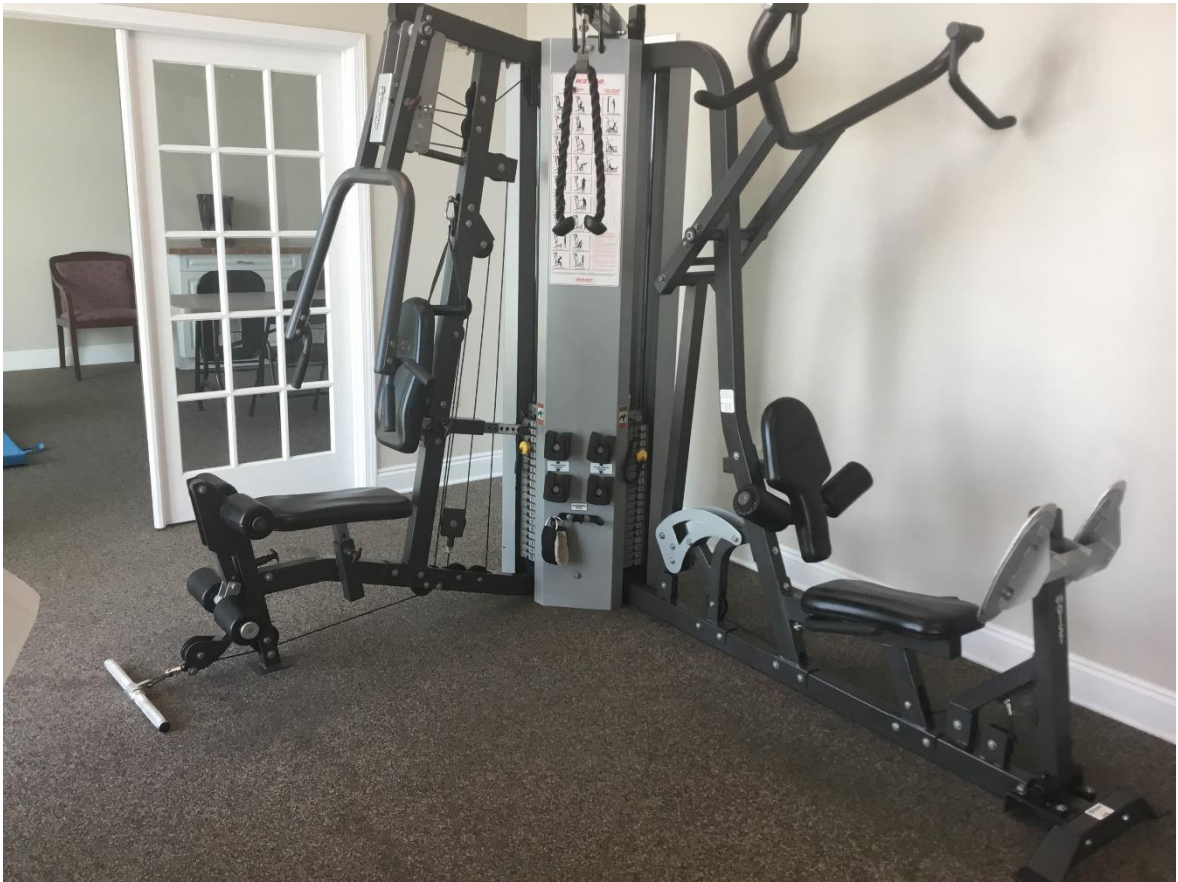
**EXHIBIT NUMBER: 1.29**

This picture depicts a portion of the exercise equipment, which was observed to be in “fair” condition.

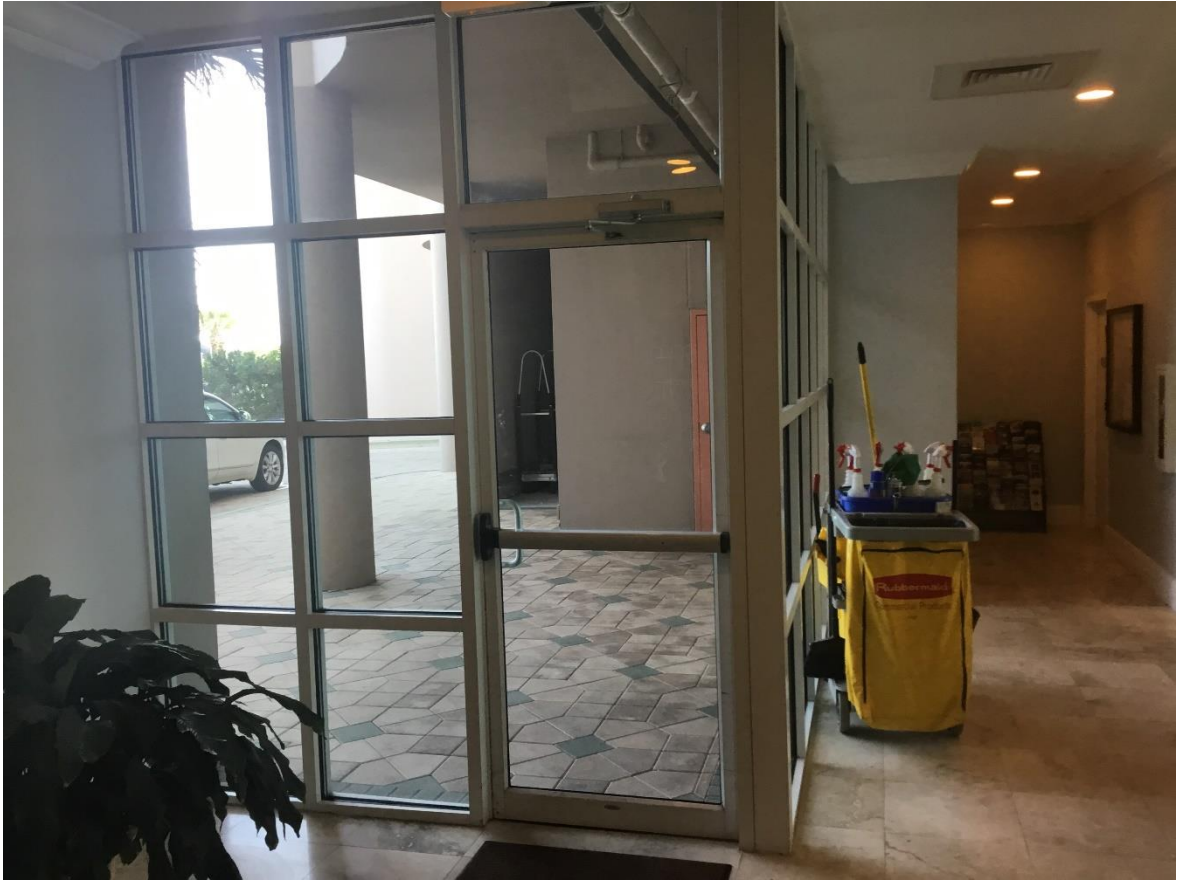
**EXHIBIT NUMBER: 1.30**

This picture depicts a portion of the lobby interior, which was observed to be in “good” condition.
